# Traction Sheave Maintenance

How to identify and prevent traction sheave damage due to unequal rope tension

by John W. Koshak and Tim Ebeling

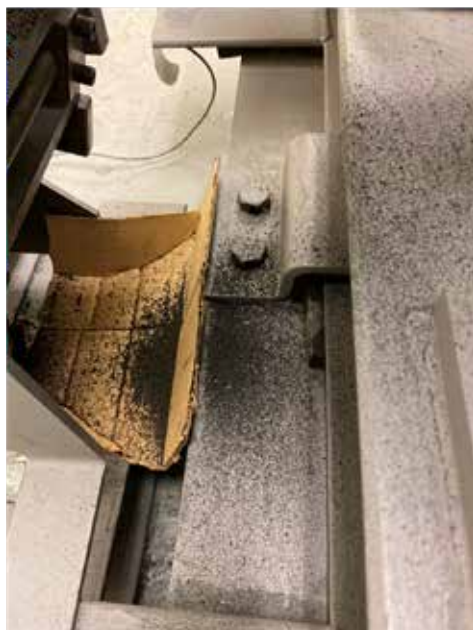
Figure 1 shows the accumulation of magnetic, steel particles under the counterweight-side pinch point of a geared traction driving machine. The elevator has a maximum speed of 1.75 m/s (350 ft/m), 11 stops, a front entrance only, runs an average of 1,700 times a day and is only seven years old. It is one of a triplex of units, yet the others (with same duty) do not show this loss of sheave material. What is the difference?

Figure 1: Example of metal particles under a pinch point

The owner was advised the sheave needs to be replaced, but determining who is responsible for the damage (absent finding the exact cause of the material loss) is a challenge. The maintenance company asserts the materials are defective; the manufacturer asserts the maintenance company is

The increasing tension in the down run is highlighted on the left, and the decreasing tension in the up run is highlighted on the right. That variant tension causes rope slip and the much harder steel wire rope to grind sheave material as seen in Figure 1.

In Figure 1, this elevator's rope tension differences began a destructive course when the first material began grinding off the sheave groove due to unequally tensioned steel wire ropes. This was caused by maladjustment of the fastening, reduced rope diameter and reduced traction groove diameter. This loss of material then further prevents equalizing the rope tensions, further damaging the sheave groove. The initial culprit was unequal rope tensions from turnover, then never checking them again, then (even worse) seeing the ground particle material under the machine and still not correcting it. Proper maintenance should have been performed to verify 10% tension annually and adjust the rope tensions and measure the groove depths.

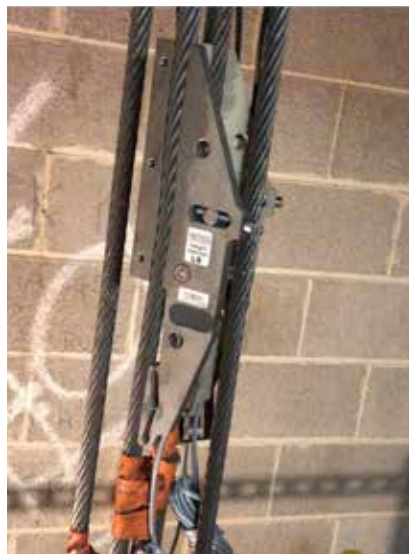
Figure 2: Henning LS1 rope gauge

WEARwatcher measures the dynamic rope tensions, which your authors considered the first place to look for the answer. Figure 2 shows the Henning LS-1 rope gauge when examination of the issue began.

WEARwatcher incorporates rope gauges on each rope that provide accuracy within 2.5%. This accuracy equals or surpasses mechanical systems. A previous article by one of your authors on alternative testing (“Safety and

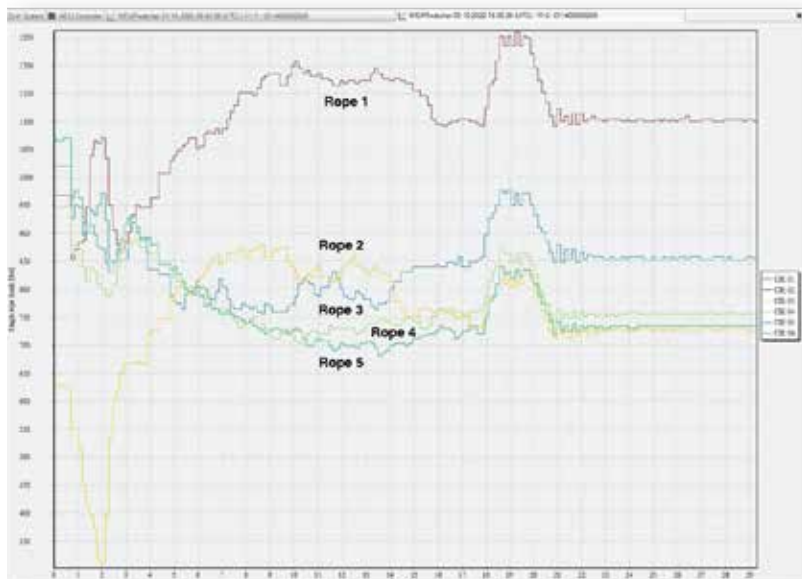
Figure 3: Rope tensions on October 9, 2020

From a stopped position, the highest tension is 1,070 lb (485 kg); 10% is 107 lb (49 kg). These ropes were out of tension by 333 lb (151 kg), approximately 31%. But, during the run, at time “13.5,” rope 1 measured 1,200 lb (545 kg), and rope 5 measured 680 lb (309 kg). So, the tension differences grew larger, a difference of 520 lb, or 43%. Therefore, WEARwatcher was sending constant error messages to equalize the ropes.

During the run, the tension differences changed: ropes 1 and 2 increased tension, while ropes 3, 4 and 5 decreased tension (Figure 3). Two things to note: measurement of the rope tensions while the elevator is stopped in the hoistway cannot determine dynamic changes, providing probably the single clearest explanation of why it is sometimes impossible to equalize rope tensions on some jobs. Seeing the changing rope tensions is a breakthrough in elevator maintenance; this is something we were unable to see before.

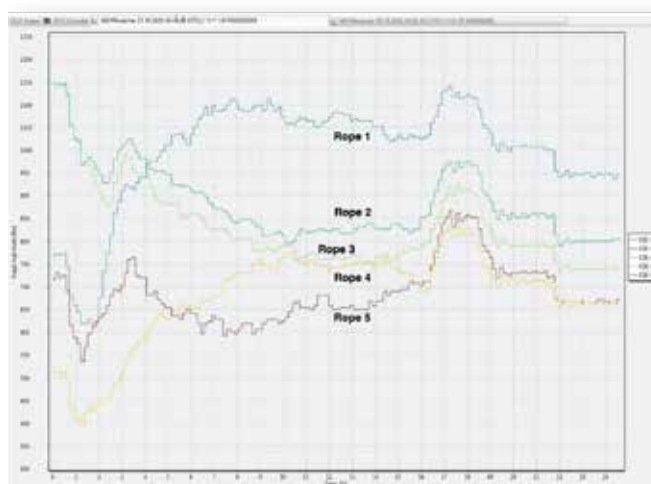
The accuracy of the gauges was called into question because the values were changing so much. To verify that the LS rope gauges were not sending out anomalous information, the maintenance contractor moved all the LS gauges to different ropes and attempted equalizing them. After this was done with the elevator at the first floor and then the car was run, there were similar unequal rope tensions again (Figure 4). The LS rope gauges were verified; they moved to ropes of different tensions as shown by the color changes in the graphs. The gauge was assigned a color, and moving it to another rope changed the rope color. In Figure 3, “brown” was on rope 1, then moved to rope 5 in Figure 4. After proving the LS rope gauges were not the problem, the next step was to concentrate efforts on equalizing the ropes. This was attempted, as shown in Figure 5.

Figure 4: Chart of rope tensions on October 11, 2020

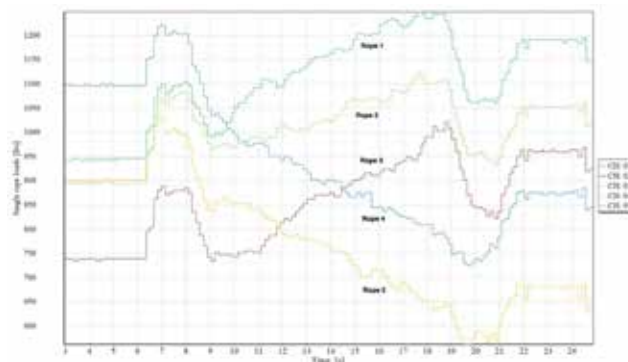
Figure 5: Chart of rope tensions on October 29, 2020

After using traditional equalizing procedures, the resultant tensions were still very divergent after running the elevator up and down several times. Measuring the tensions, adjusting the shackles, then running the car put the ropes out of balance every time. Looking closer at the Figure 5, during this run, ropes 1, 2 and 3 show increasing tension, while ropes 4 and 5 showed decreasing tension. Looking back at Figures 3 and 4, this also documents rope tensions that increased and decreased during travel.

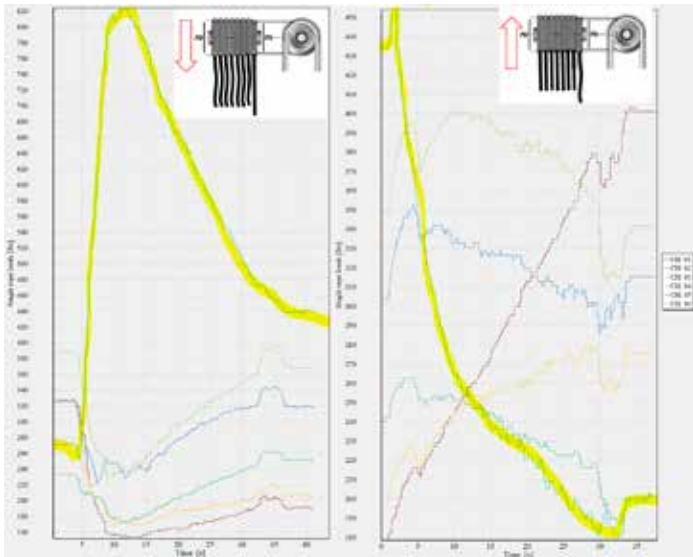
Figure 6: Illustration of tension changes with diameter differences; courtesy of Henning

Figure 6 shows this behavior in an extreme example. The highlighted rope is from two recordings of different elevators.

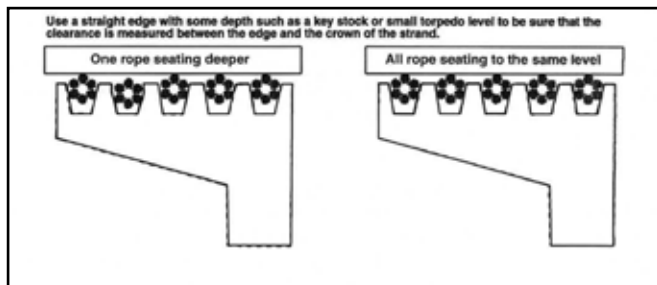
Figure 7: Illustration determining groove depths; from *Elevator Maintenance Manual* by Zack McCain

Determining the condition of the relative sheave groove depth/rope diameter is done by placing a straightedge across all the ropes at the top of the sheave (overhead driving machine) or at any point where all the ropes are fully in the grooves (Figure 7). Careful measurement for any variance in the rope crown heights will show either a rope or groove diameter difference. Where the traction sheave has grooves deeper than the outer edge of the sheave, place the straightedge, and use feeler gauges to measure if the gaps over the crown are equivalent.
